Kintore Hydrogen Plant Bat Activity Surveys of Buildings

December 2023

Client: Kintore Hydrogen Limited
 Project Title: Kintore Hydrogen Plant
 Report Title: Bat Activity Surveys of Buildings
 Document number: 13595
 Project number: 376782

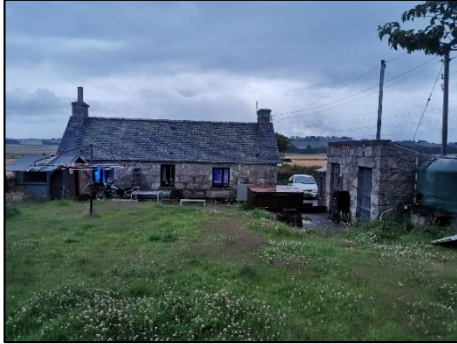
The residential building comprised a one storey stone walled and slate pitched roof cottage, with a flat bitumen felt roof and rough cast wall extension on the south aspect. A chimney stack was present on either gable end (Photograph 1).

The associated outbuilding comprised a small single storey stone walled and slate sloping roof, with two wooden doors on the east aspect (Photograph 1).

Photograph 1: Residential building and outbuilding (north aspect) in the central region of the site

The cottage building and outbuilding are to be retained in the development design and no summer roosting bats were identified within the buildings, therefore no further survey is recommended, and there are currently no requirements for a licence from Nature Scot prior to any works commencing.

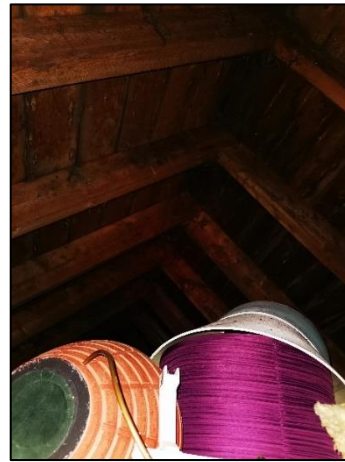
Internally, the cottage building comprised of a false ceiling of the room where the loft entry point was situated which consisted of a one foot high space which was covered in wood clad. The main loft area consisted of wooden sarking and wooden trusses, with insulation in floor area (Photograph 2).

No obvious signs of light were apparent, and the loft space appeared in good condition.

Photograph 2: Loft area of residential cottage building

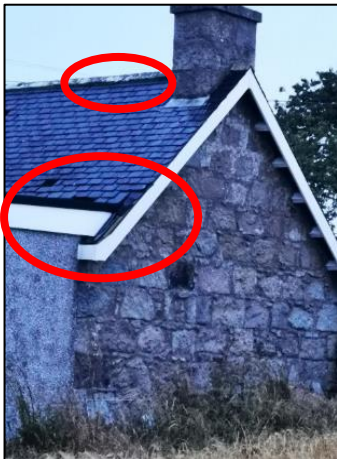
- Gaps under slates (Photograph 3)
- Gaps under apex ridge (Photograph 3)
- Gaps between bitumen felt roof and fascia boards

Photograph 3: Gaps under cottage roof slate and apex tile

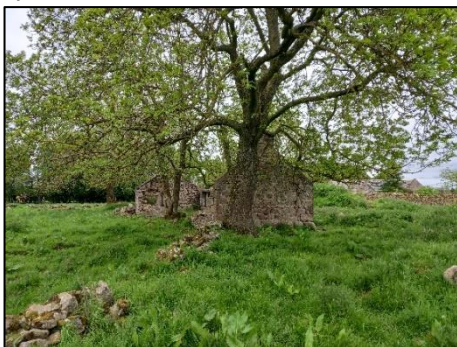
Photograph 5: Ruined building in the west of the site (proposed electrolysis plant area)

The ruined building is to be retained and no summer roosting or winter hibernating bats were identified during the detailed endoscope surveys of the ruined building, therefore no further surveys are recommended and there are currently no requirements for a licence from Nature Scot prior to any works commencing.

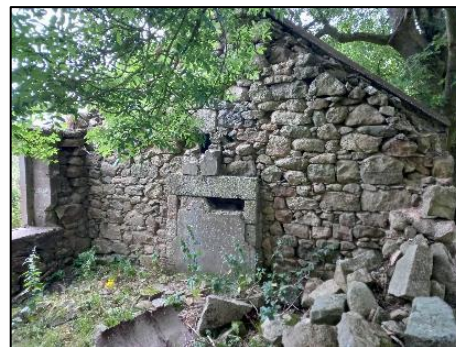
- Gaps in stonework where masonry deteriorated (Photograph 6)
- Gaps between chimney flue and stonework (Photograph 6)
- Gaps under remnant slates (Photograph 6)
- Gaps in wooden door frame and stone lintel (Photograph 7)
- Gaps under the internal remnant roofline (Photograph 6)

Photograph 6: Gaps between ruined building's stonework where masonry has deteriorated, between masonry and remnant roofline and gaps between ruined building's chimney flue and stonework

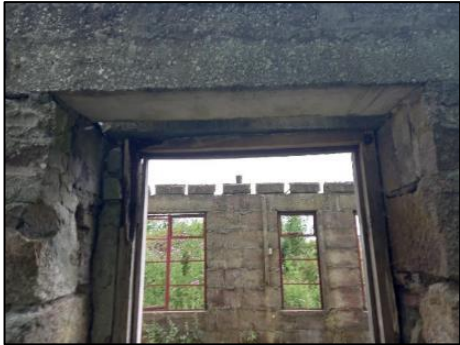
Photograph 7: Gaps in ruined building's wooden frame and stone lintel
