# **Kintore Hydrogen Plant Fish Habitat Assessment and Freshwater Pearl Mussel Survey**

**December 2023**

Client: Kintore Hydrogen Limited  
 Project Title: Kintore Hydrogen Plant  
 Report Title: Fish Habitat Assessment and Freshwater Pearl Mussel Survey  
 Document number: 13885  
 Project number: 376782

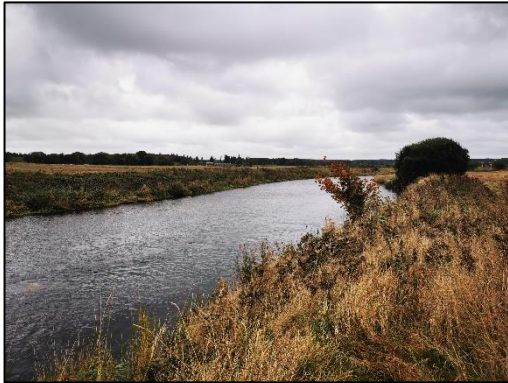
Photograph 1: Vegetated banks along River Don in downstream section surveyed

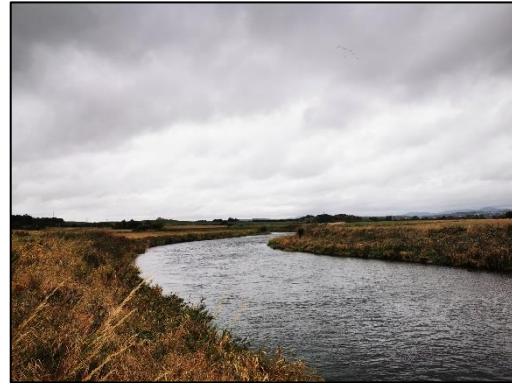
Flow conditions were low at the time of survey, with the water clear and flow speed slow-moderate (Photograph 2). The flow type was fairly consistent with run and deep glide dominating, with shallow glide and areas of still marginal and occasional pooling (deep and shallow) present throughout.

Photograph 2: Vegetated banks continuing in upstream section surveyed

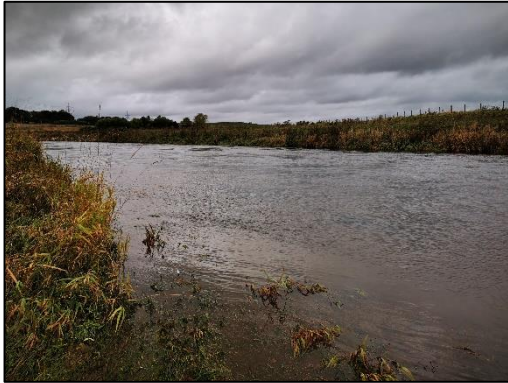
A range of substrates are present (silt, sand, gravel, pebble, cobble, and boulder) however, although gravel was present in the River Don, it was present in low volumes and therefore considered too small to be classed as providing suitable for spawning salmonids (Photograph 3).

Photograph 3: Small gravel and pebble area at 500m downstream of site

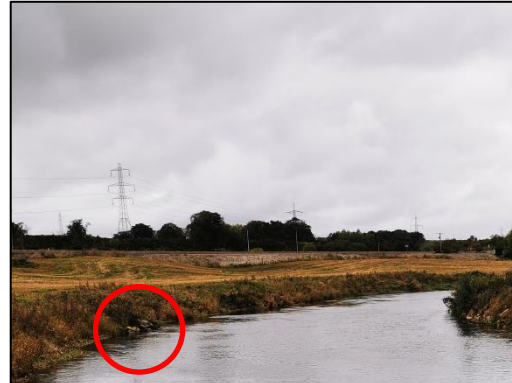
In general, this stretch was considered unstable and uncompacted due to a general lack of inchannel vegetation apart from tenacious *Ranunculus* in the section along the site boundary of the site (Site Code: K005 and K006 in Appendix A and D). This section of the River Don also shows signs of modification via bankside erosion control boulders which has likely altered the natural flow of the watercourse in areas, resulting in changes to flows such that sand, gravel and pebbles do not settle amongst cobbles and boulders (Photograph 4).

Photograph 4: Large boulders which alter natural flow of River Don

Removal of large boulders as part of bank modification to allow a more natural flow regime and where required replace with green bank supports.

- Restoring riparian corridor associated with the River Don as trees lacking along bank. Planting of native trees which are water tolerant is recommended;
- Inclusion of woody debris in the River Don to provide improved habitats and water quality for a range of species including fish and FWPM; and
- Removal of large boulders as part of bank modification to allow a more natural flow regime and where required replace with green bank supports.
